FEDERAL EMERGENCY MANAGEMENT AGENCY

Above the Flood: **ELEVATING YOUR FLOODPRONE HOUSE**

MITIGATION DIRECTORATE

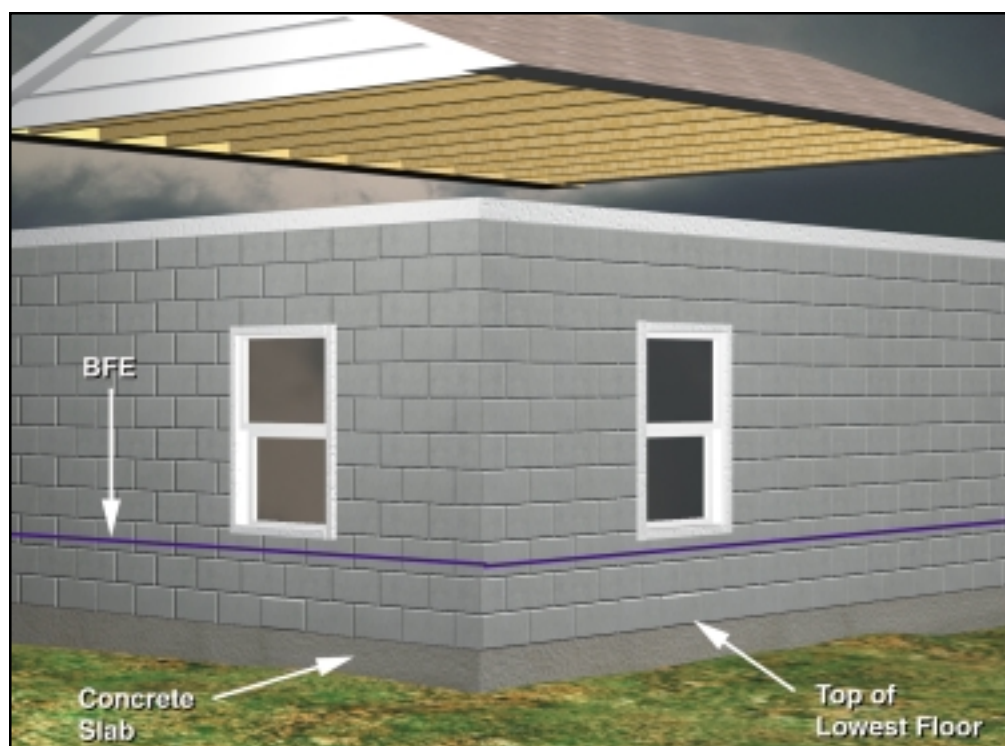
Figure 10
The first step in Technique 1 is removing the roof.

Technique 1 is appropriate for houses with concrete or masonry walls, but not for houses with other types of walls, such as those framed with wood studs, which would be more vulnerable to flood damage. This technique is usually appropriate when the depth of the base flood at the house is no more than 4 or 5 feet above grade. The elevation process begins with the temporary removal of the roof and roof framing, in a single piece if possible (Figure 10). This is commonly done with a crane. The roof is then stored on site so that it can be reinstalled later. The next step is to remove the windows and doors.

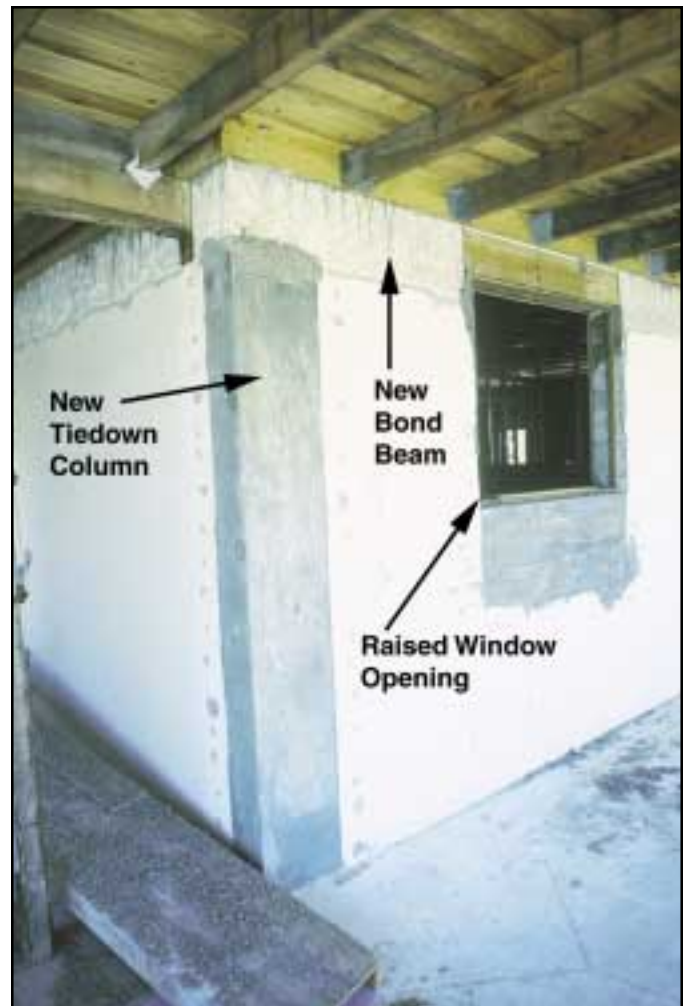
**Figure 41**

Note the new bond beam at the top of the extended wall, the new concrete tiedown column at the corner, and the raised window opening.
